Health & Safety – Site Inspection Report

Client Name: Command Electrical Ltd
Date & Time: 29th November 2021
Site Address: Bromley Football Club, Bromley, BR2 8NH
Inspection By: Steve Walder
Site Contacts: Mark Jones

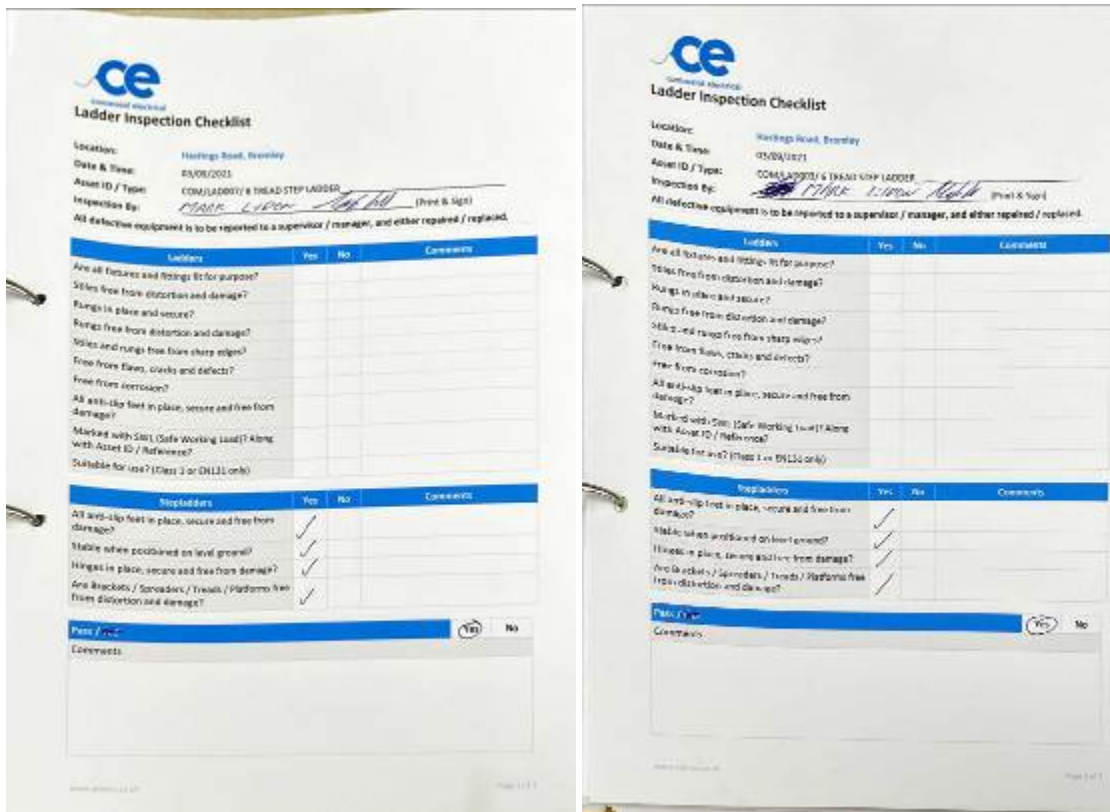
| Observations and Comments |
|---|
| Step ladders are used to gain low level heights. These are inspected pre use and more formally which is documented. Sampled |

Sampled ladder inspections

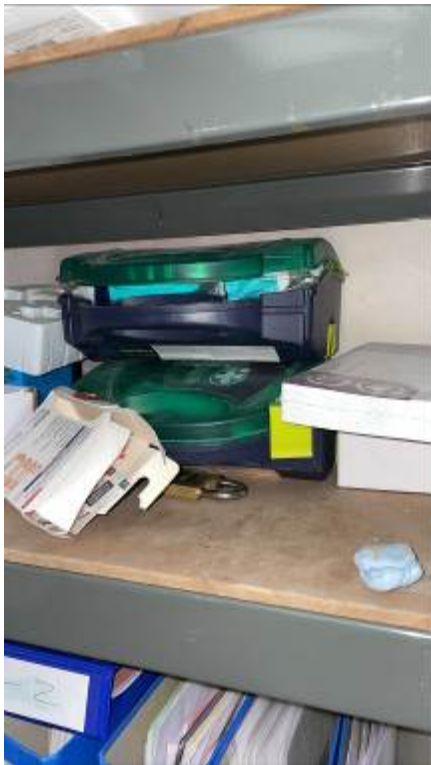
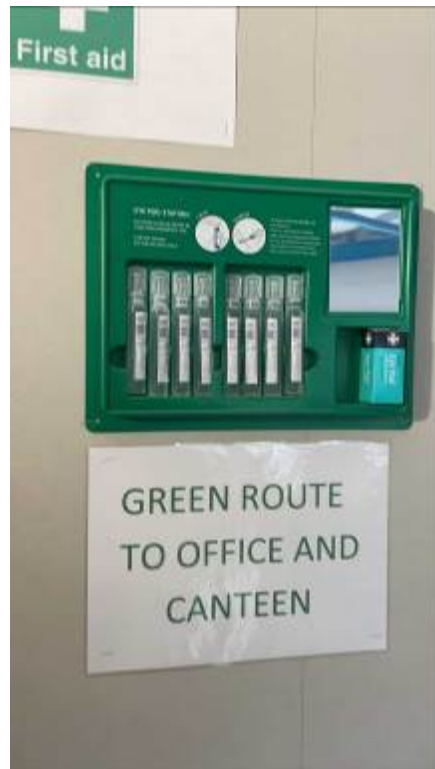
| Observations and Comments |
|--|
| <p>First Aid Coldrum Homes (PC) provide all first aid related procedures and facilities. Kits held in the site office and eye wash station outside office on wall. Command contractors are informed of these arrangement’s art the site induction.</p> |

Emergency first aid kits and eye wash.

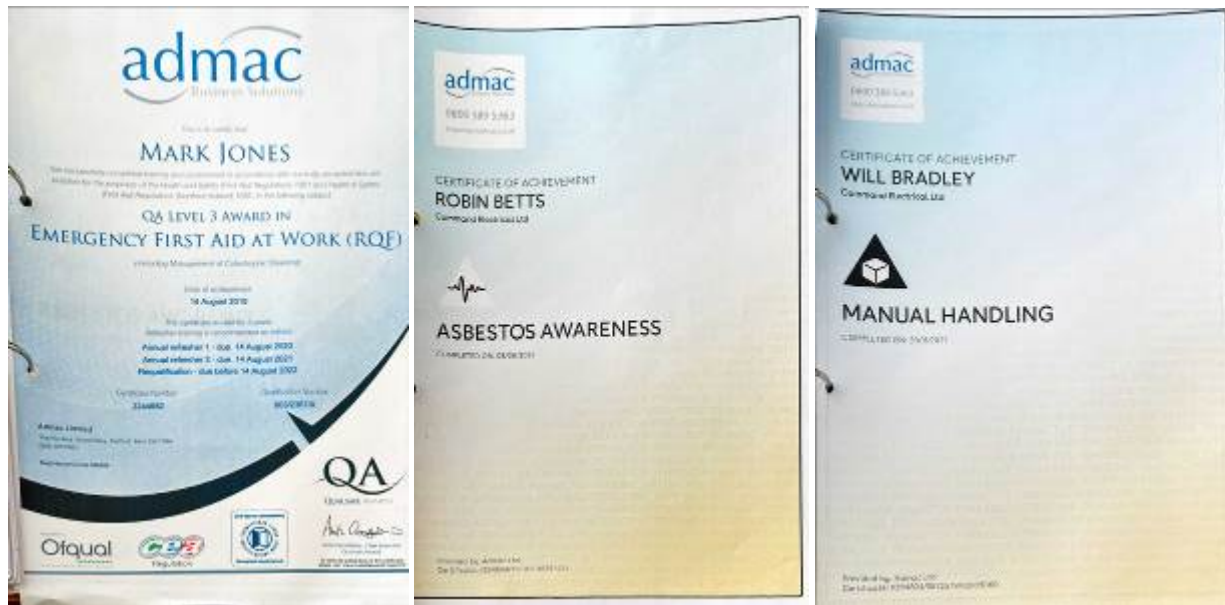
Sampled training certification.

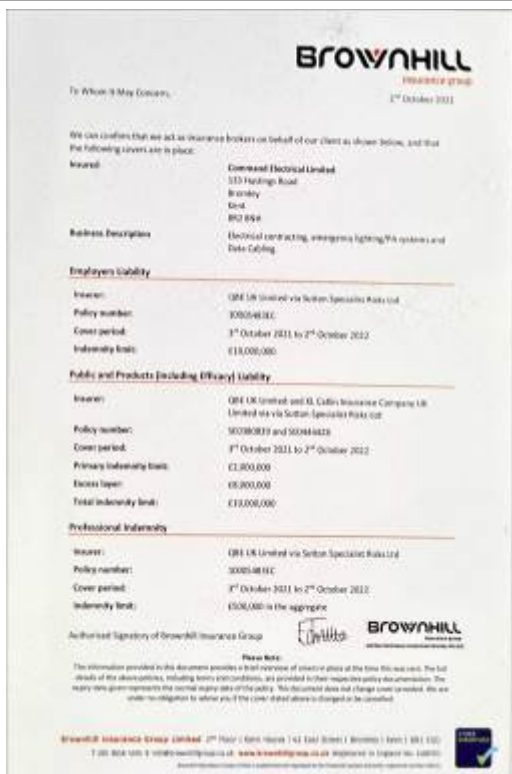
| Observations and Comments |
|--|
| <p>Insurance Provided by Brownhill Insurance Group, expiry 02/10/2022.</p> |

Insurance dated Oct 2022.

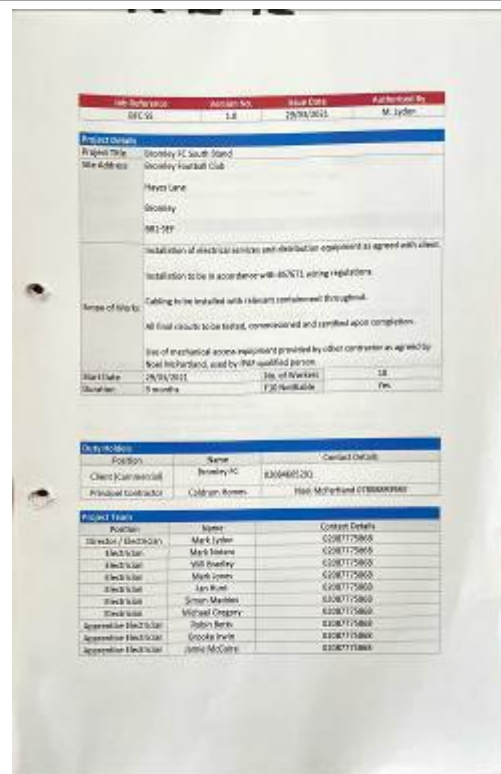
| Observations and Comments |
|---|
| RAMS A site-specific set of RAMS had been written for this project. Mark informed me that the project is likely to be extended due to many add on's throughout. The risk assessment section had covered the expected hazards for the project from Commands perspective. The RAMS had been given to the PC although there were no acceptance documents to indicate their acceptance. |

Front page of RAMS.

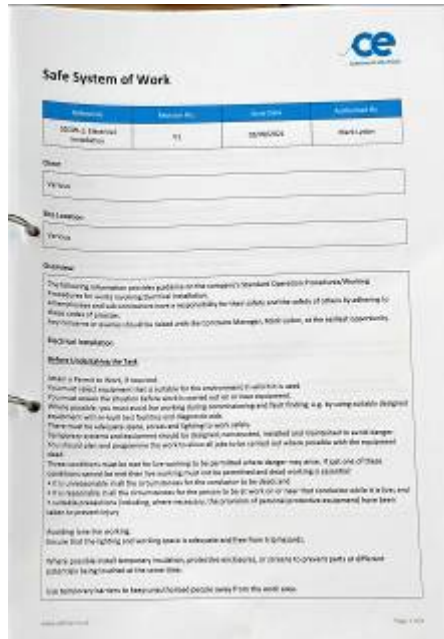
| Observations and Comments |
|--|
| <p>SSOW There were a number of safe systems of work filed, sampled was Electrical Installation as this was the most relevant with the highest risk in use on this project. The document had been authorised by Mark Lydon and was dated 03/09/2021.</p> |

Sampled safe system of work.
